Analysis report coarse sand barrier

Delta Flume tests (phase 2c)

Client	Project	Attribute	Pages
Waterschap Rivierenland	11200952-012	11200952-012-GEO-0001	92

Piping, preventive measure, coarse sand barrier, innovation, large-scale, scale effects, Delta Flume

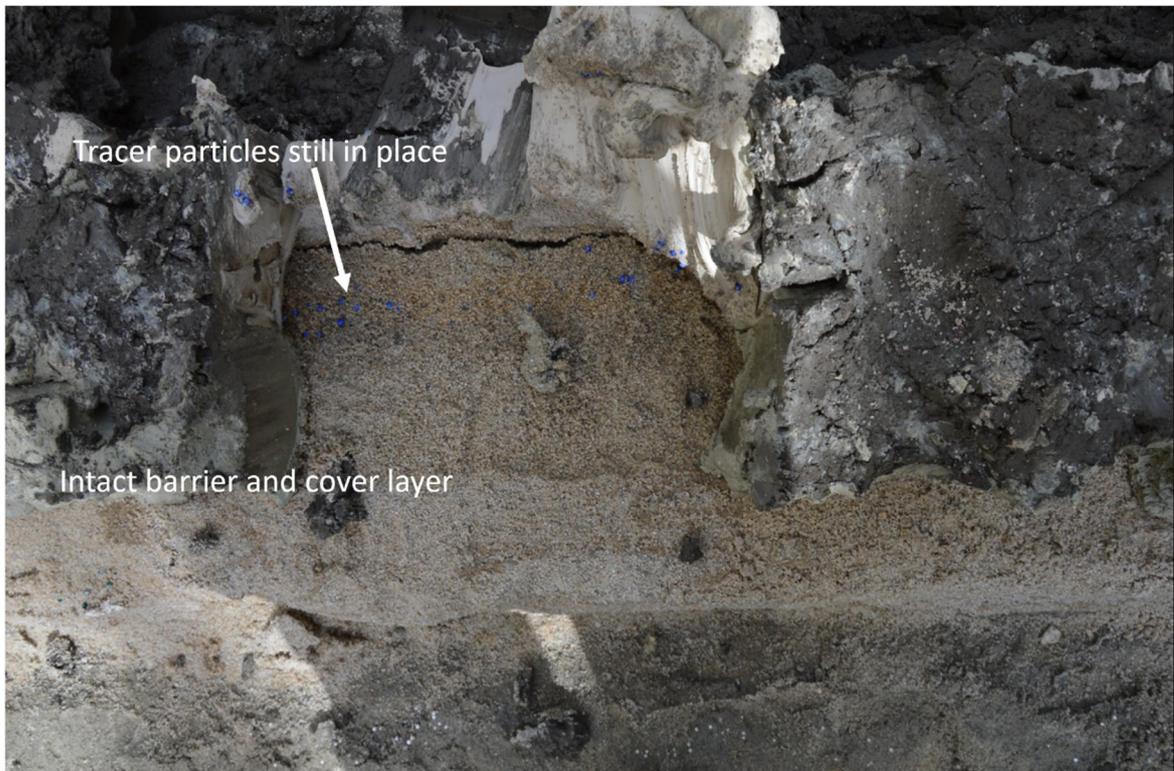
Figure 4.11 Excavation indicating intact barrier on the north side of the model, top view of the barrier

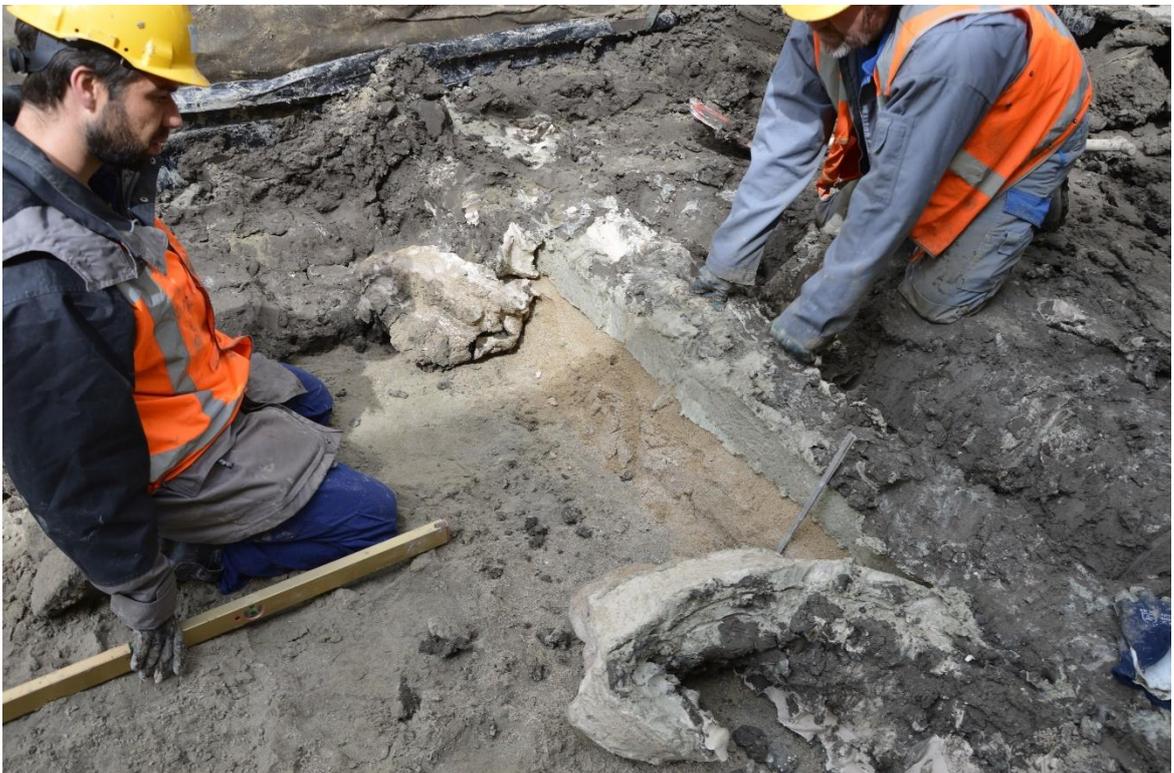
Figure 4.15 Intact barrier on the north side of the set-up.

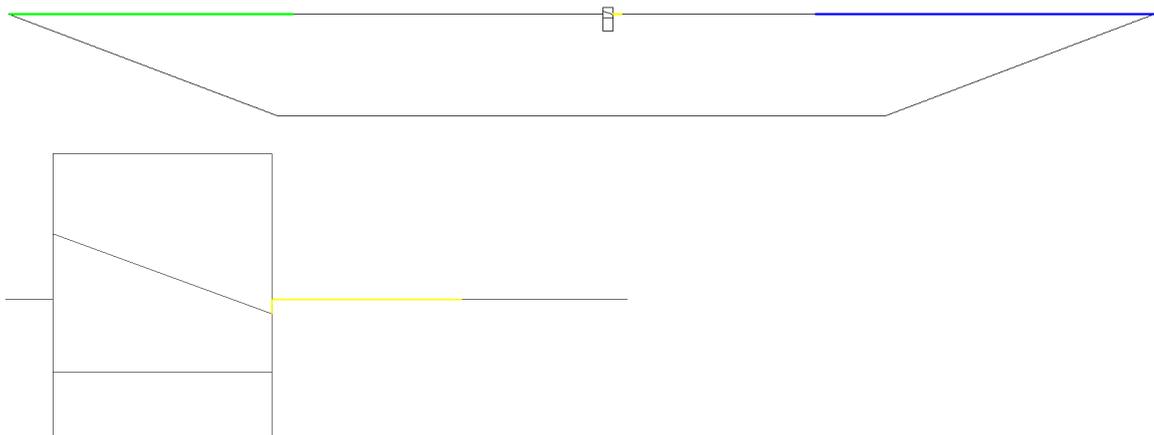
Figure 7.3 Boundary conditions in the Delta Flume model of the first test, green is upstream head, yellow is head in pipe at the barrier, blue is head in ditch downstream. Top overview of entire model, bottom close-up of the barrier.

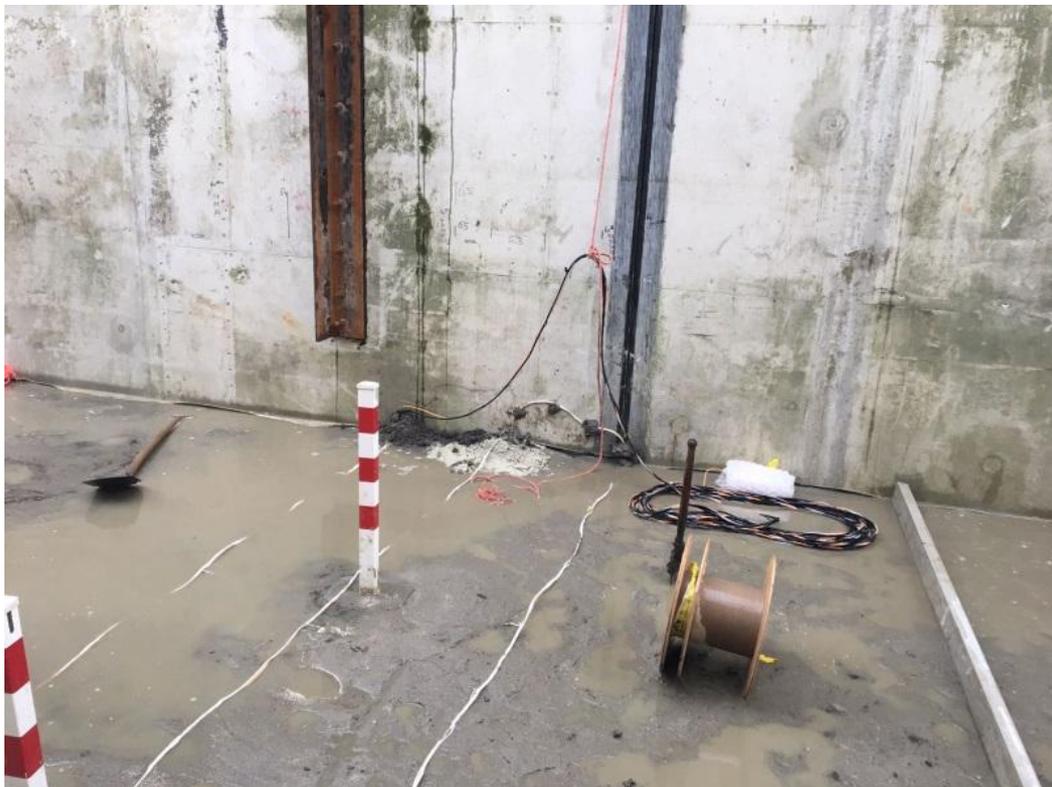
Figure 3 - Photo of the fibre optic cable on the sand bed.
