## Analysis Report Coarse Sand Barrier Verification Tests

Analysis of medium-scale configuration with protuberance (phase 3)

<b>Client</b>	Waterschap Rivierenland
<b>Contact</b>	B. Heutinks, <a href="mailto:B.Heutink@wsrl.nl">B.Heutink@wsrl.nl</a>
<b>Reference</b>	-
<b>Keywords</b>	Piping, preventive measure, coarse sand barrier, innovation, medium-scale, scale effects, protuberance, physical modelling, GZB, CSB

<b>Version</b>	1.0
<b>Date</b>	17-03-2021
<b>Project nr.</b>	11200952-063
<b>Document ID</b>	11200952-063-GEO-0001
<b>Pages</b>	145
<b>Status</b>	final

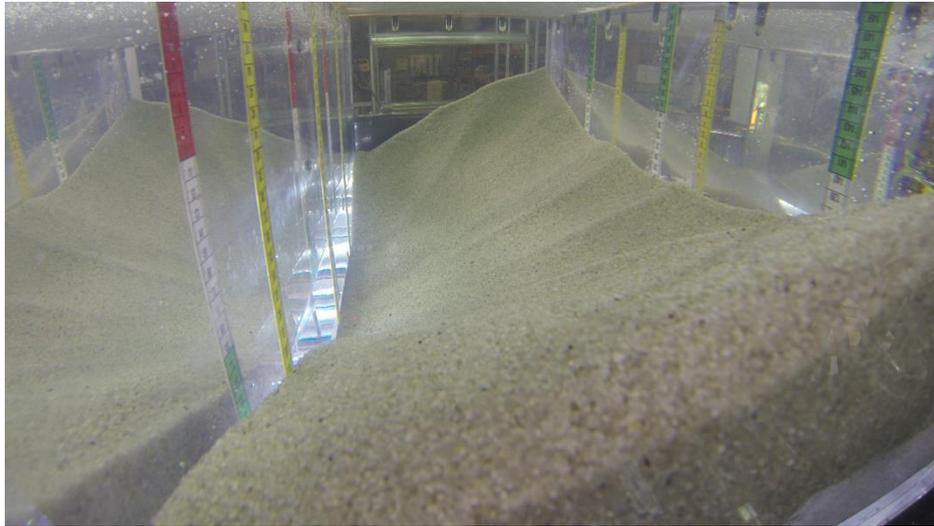
*Figure 3.10 Test MS 38, end of stage IV. Situation before applying the last load step.*

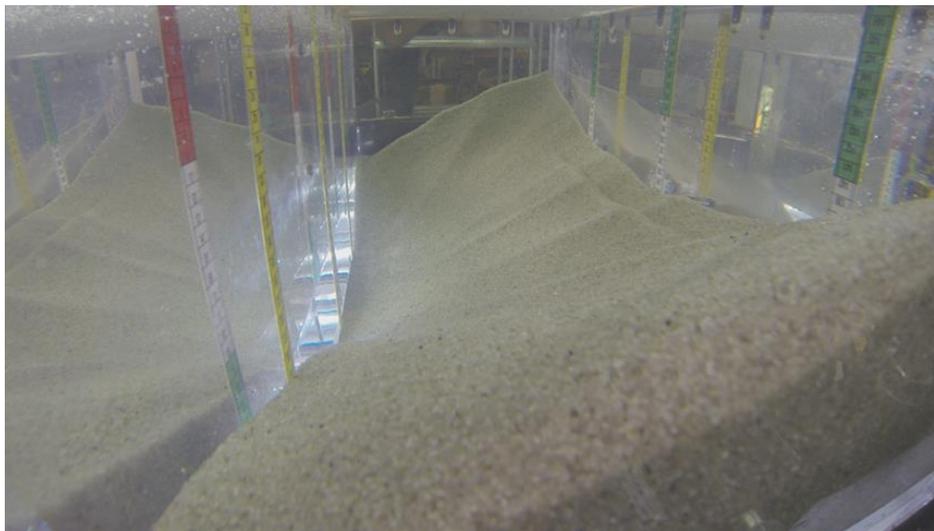
*Figure 3.11 Test MS 38, beginning of slope failure. The toe of the slope is subsiding.*

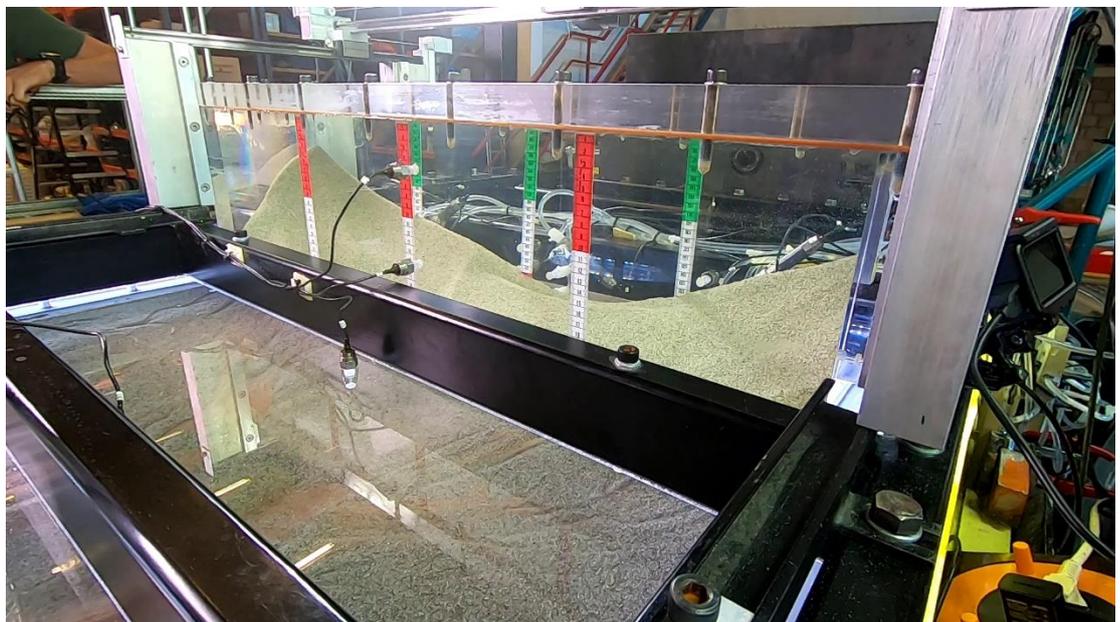
Figure 3.26 MS 40. Sliding of the slope resulting in an increase of coarse sand moving above the downstream sand bed. (seen from the downstream side).

Figure 3.24, Figure 3.25 and Figure 3.26 show the moment of sliding of the slope from different directions. From a comparison of GoPro footage from the moment of failure, seen from the upstream and downstream side of the protuberance (Figure 3.27), it can be concluded that after the last load increment has been applied a strong erosion process was starting. Sand particles were moving over the whole slope surface and transported to the downstream sand bed. This is also visible on the photos taken from above the set-up. The upstream sand bed was still intact, when the crest of the slope was already sliding. The crest of the slope was subsiding first, followed by an upward movement of the lower part of the slope, pushing this part against the downstream wall of the protuberance. Subsequently, the upstream sand bed begins to fluidize and move downstream. Finally, there is a blowout at the upstream edge of the protuberance. From this we can conclude that the barrier slope is sliding along a slide surface below the lower edge of the protuberance (i.e. at a level below the cover layer).

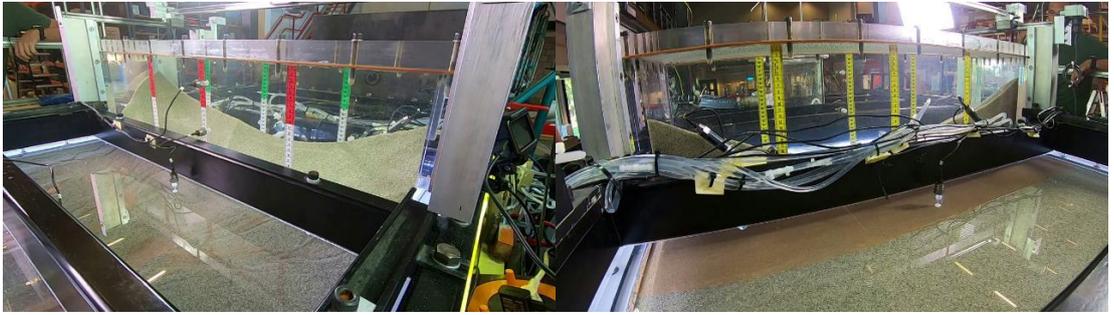
Figure 3.32 Test MS40. This is the moment that the slope is already sliding (left image). On the right image there is still no movement of the upstream sand bed noticeable.
